Comparative imaging of European eels (*Anguilla anguilla*) for the evaluation of swimbladder nematode (*Anguillicoloides crassus*) infestation

Frisch, K, Davie, A, Schwarz, T & Turnbull, J 2016, 'Comparative imaging of European eels (*Anguilla anguilla*) for the evaluation of swimbladder nematode (*Anguillicoloides crassus*) infestation', *Journal of Fish Diseases*, vol. 38, pp. 635-647. <https://doi.org/10.1111/jfd.12383>

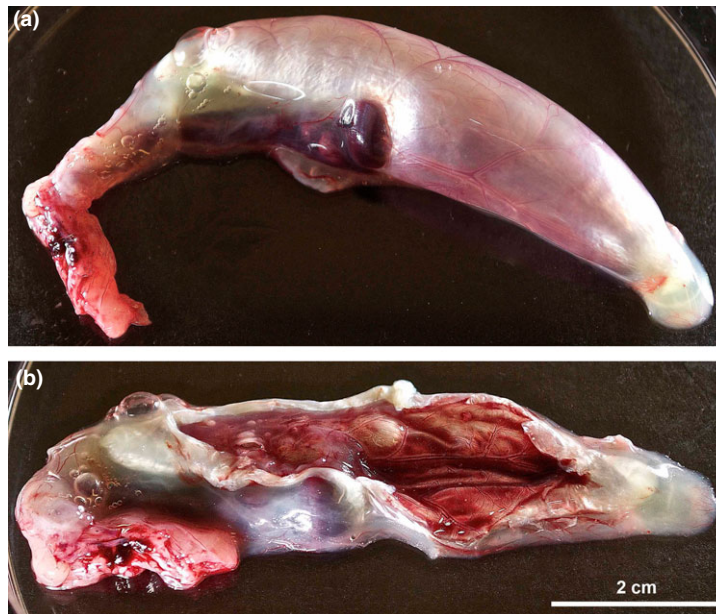
Figure 3 *Anguilla anguilla*, no. 5. (a) Unopened and (b) opened swimbladders dissected from eel in Fig. 1. Wall is transparent and thin walled, and lumen is worm free.

was transparent and thin walled (wall thickness < 1 mm) (Fig. 3).

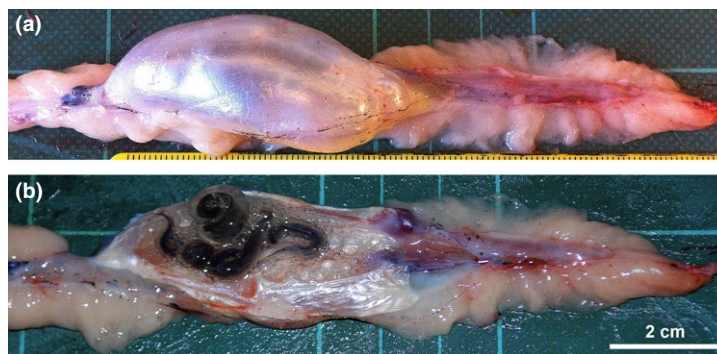
Figure 6 *Anguilla anguilla*, no. 1. (a) Unopened and (b) opened swimbladders dissected from eel in Fig. 4. Wall is opaque and thickened, the caudal end is atrophied (right image side), and the lumen is filled with worms (arrow) and some exudate.
